West Side Federation for Senior & Supportive Housing & Patterson-Kelley Boilers

An in-depth look into the application of Patterson-Kelley THERMIFIC boilers over a 25 year period. This whitepaper shows the longevity of PK equipment when properly and routinely maintained and some of the minor upgrades needed to keep a boiler room active for decades.

Building #1: 2 Patterson-Kelley Thermific Boilers (Mfg. 1995)

Building #2: 1x Patterson-Kelley Thermific Water Heater (Mfg. 1997)

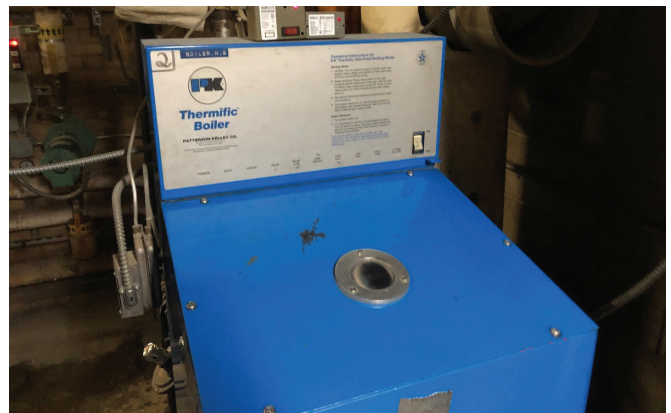
The first building features two Patterson-Kelley Thermific model N-900 boilers originally manufactured in the

summer of 1995 and installed prior to the start of the '95-96 heating season. For 25 consecutive years, these 900,000 BTU/Hr natural gas fired boilers have been providing reliable hydronic heating AND domestic hot water to all the residents and WSFSSH staff.

25 years later: original heat exchangers, original burners, original gas valves, original blowers all intact. This happens when the owner invests in routine, preventative maintenance and is a testament to WSFSSH's commitment to their residents.

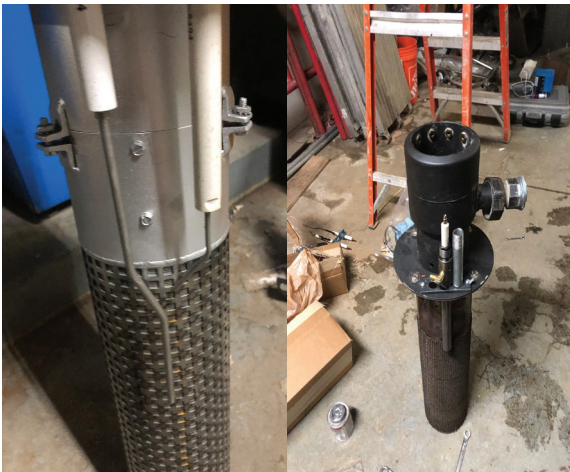
In early 2020, the boilers started to experience ignition/flame failures. Upon investigation by Accardi Companies technicians, it was determined the boilers were igniting reliably and combustion was tuned properly, but the original flame rod monitoring system on the steel core burner (below left) was not reliably monitoring and reporting back the flame signal:

As the flame rod heats up during normal boiler operation, it has a tendency to migrate which reduces the flame signal strength as it moves further away from the burner cylinder. In order to improve the reliability of the flame signal and simultaneously reduce CO and NOx emissions, stainless steel mesh style burners were installed in both boilers, along with an external pilot assembly complete with UV flame monitoring (above right).

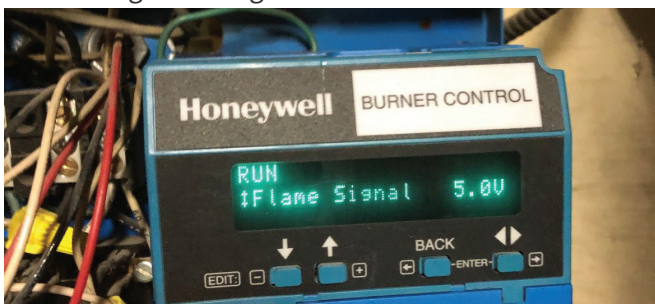
After installation, there was an immediate improvement in the flame signal strength at solid 5.0V as shown below:

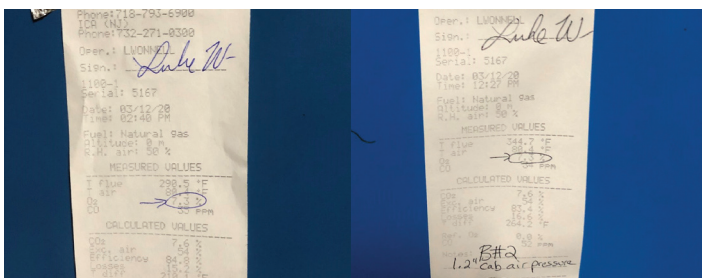
After verifying the upgraded boilers were fully functional and all safety limits tested, combustion adjustment and efficiency testing was completed,

When these boilers left the Patterson-Kelley factory in 1995, their operating efficiency was 85%. Fast forward 25 years and Boiler #1 is still able to achieve 84.8% efficiency and Boiler #2 83.4% efficiency!

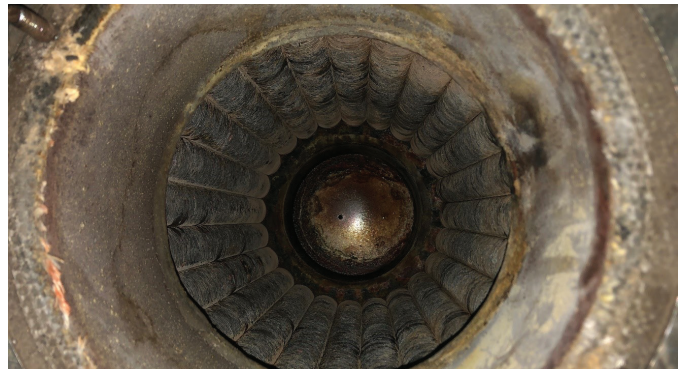
The image below shows the inside of the Patterson-Kelley Thermific copper finned-tube heat exchanger: thirty vertical copper-finned tubes arranged into three passes, ten tubes per pass. 25 years of year-round operation and all thirty tubes are present and accounted for and fully intact.

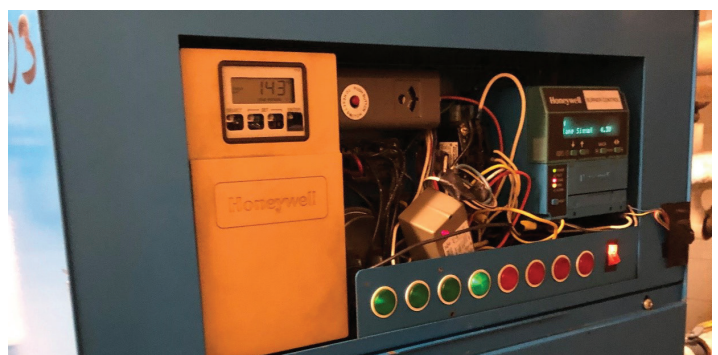
The next building features QTY 1x Patterson-Kelley Thermific model D1900-2 water heater originally manufactured in 1997. For 23 consecutive years, this 1,900,000 BTU/Hr 2-stage (low fire/high fire) natural gas fired water heater has provided reliable domestic hot water in the spring, summer and fall months outside of the NYC heating season.

23 years later: original heat exchanger, original gas valve, original blower all intact. The original steel core burner had been upgraded to the stainless steel mesh type, which dramatically reduces the CO and NOx emissions.

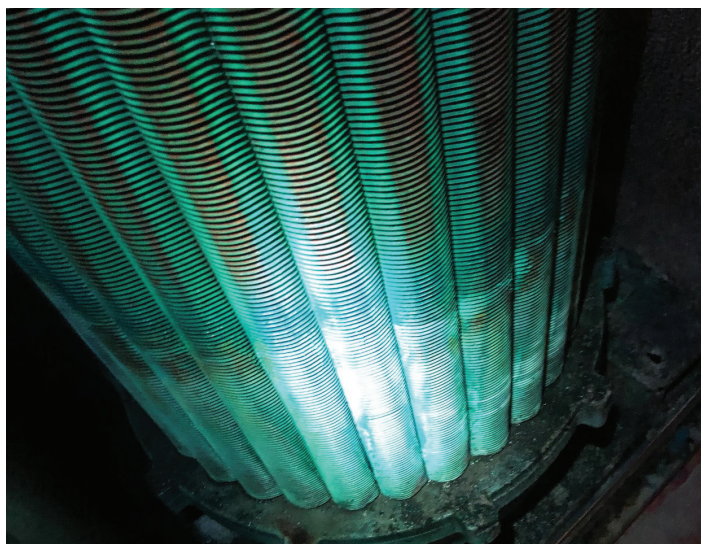
In early 2020, there was some concern by the facility staff that the water heater's heat exchanger may be compromised since there was water leaking onto the floor. Upon investigation and pressure testing by Accardi Companies technicians, the copper finned-tube heat exchanger was perfectly intact, but the water heater was subjected to heavy condensing-mode operation as shown by the green/white colored corrosion in the image below:

The temperature of combustion is roughly 2200°F, but when a nearby metal surface inside the water heater's

heat exchanger is 130°F or less, the water vapor (2H₂O) condenses back to liquid water. The water seen on the floor was not the domestic water leaking out of the heat exchanger, it was the liquid condensate forming in combustion due to the low operating temperatures.

After adjusting the operating temperature setpoint above condensing mode operation, the condensate problem was resolved once and for all.

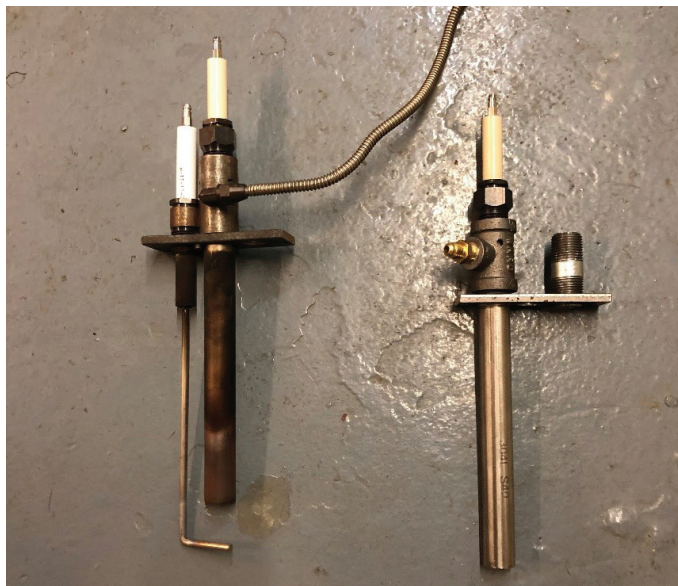
Similar to Building #1, the decision was made to upgrade from the legacy flame rod monitoring system (below left) to UV flame monitoring technology (below right):

The original flame rod (above left) was producing very inconsistent flame strength signals compared to the upgraded UV scanner which reported a solid 5.0V flame signal at ignition, low fire, and high fire:
